NAVAL POSTGRADUATE SCHOOL MONTEREY CA
A-10/GAU-8 LOW ANGLE FIRINGS VERSUS SIMULATED SOVIET TANK BATTAL--ETC(U)
AUG 80 R H STOLFI, R R MCEACHIN

A-10/GAU-8 LOW ANGLE FIRINGS VERSUS
SIMULATED SOVIET TANK BATTALION
(HONEYWELL LOT NUMBER 0L78D043-016)
(ARRAY 3)
2 FEBRUARY 1979.

AUGUST 1980

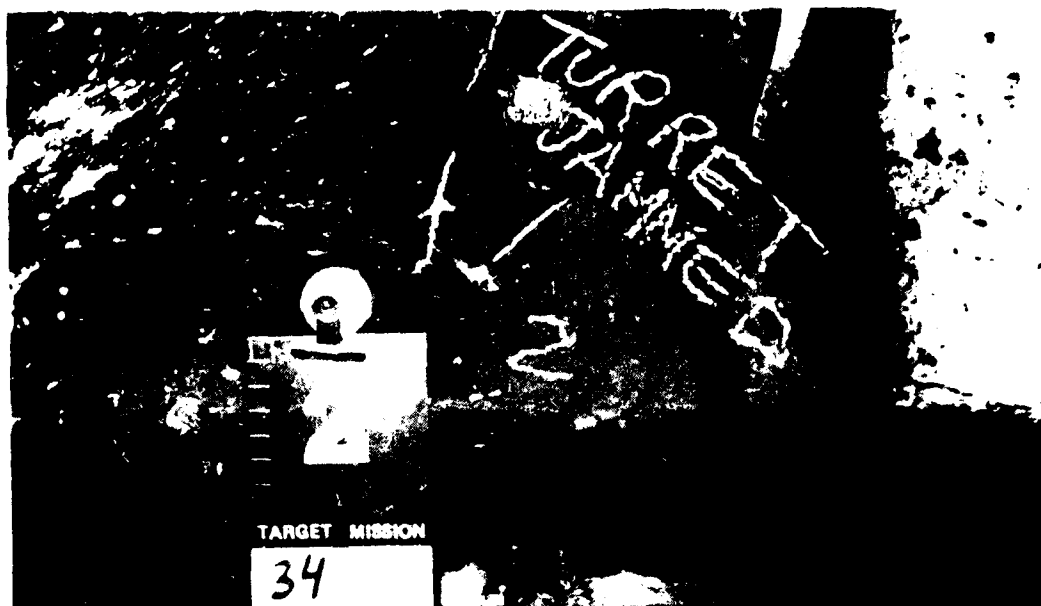
Impact 2 (Figure 70) hit between the turret and hull, bulging the armor on the inside, and jammed the turret so that it would not traverse. The perforation, shown in Figure 71, Impact 7, penetrated into the bulkhead ammunition stowage rack and into the adjacent stowage box, but did not impact any of the stowed ammunition.

FIGURE 70. Impact Two, Target 34, Penetration of Turret Ring between Hull and Turret, Armor Bulged, Turret Jammed.

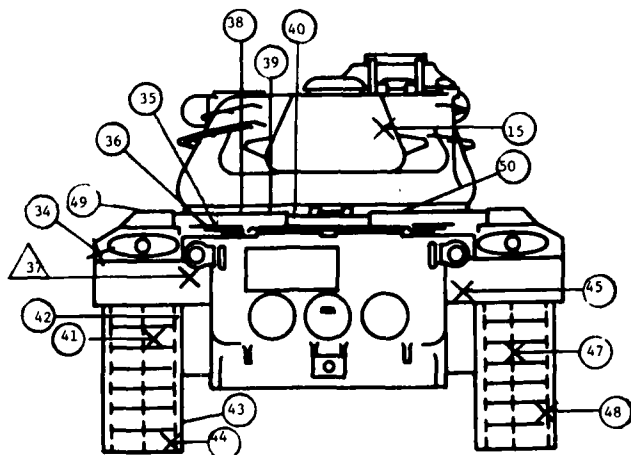
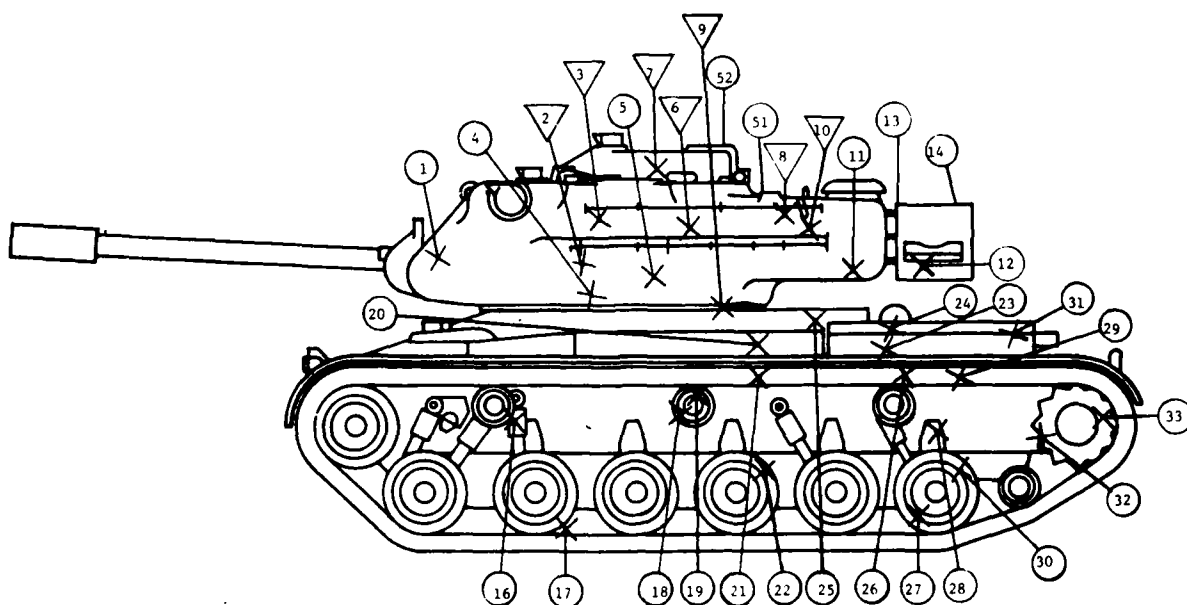
FIGURE 72. Impact Diagram, Target 35.

100% M-Kill and 100% F-Kill, resulting from the following projectile impacts, shown in Figure 72:

IMPACTS 38, 39 and 40 ON EXTENDED FUEL TANK BRACKET

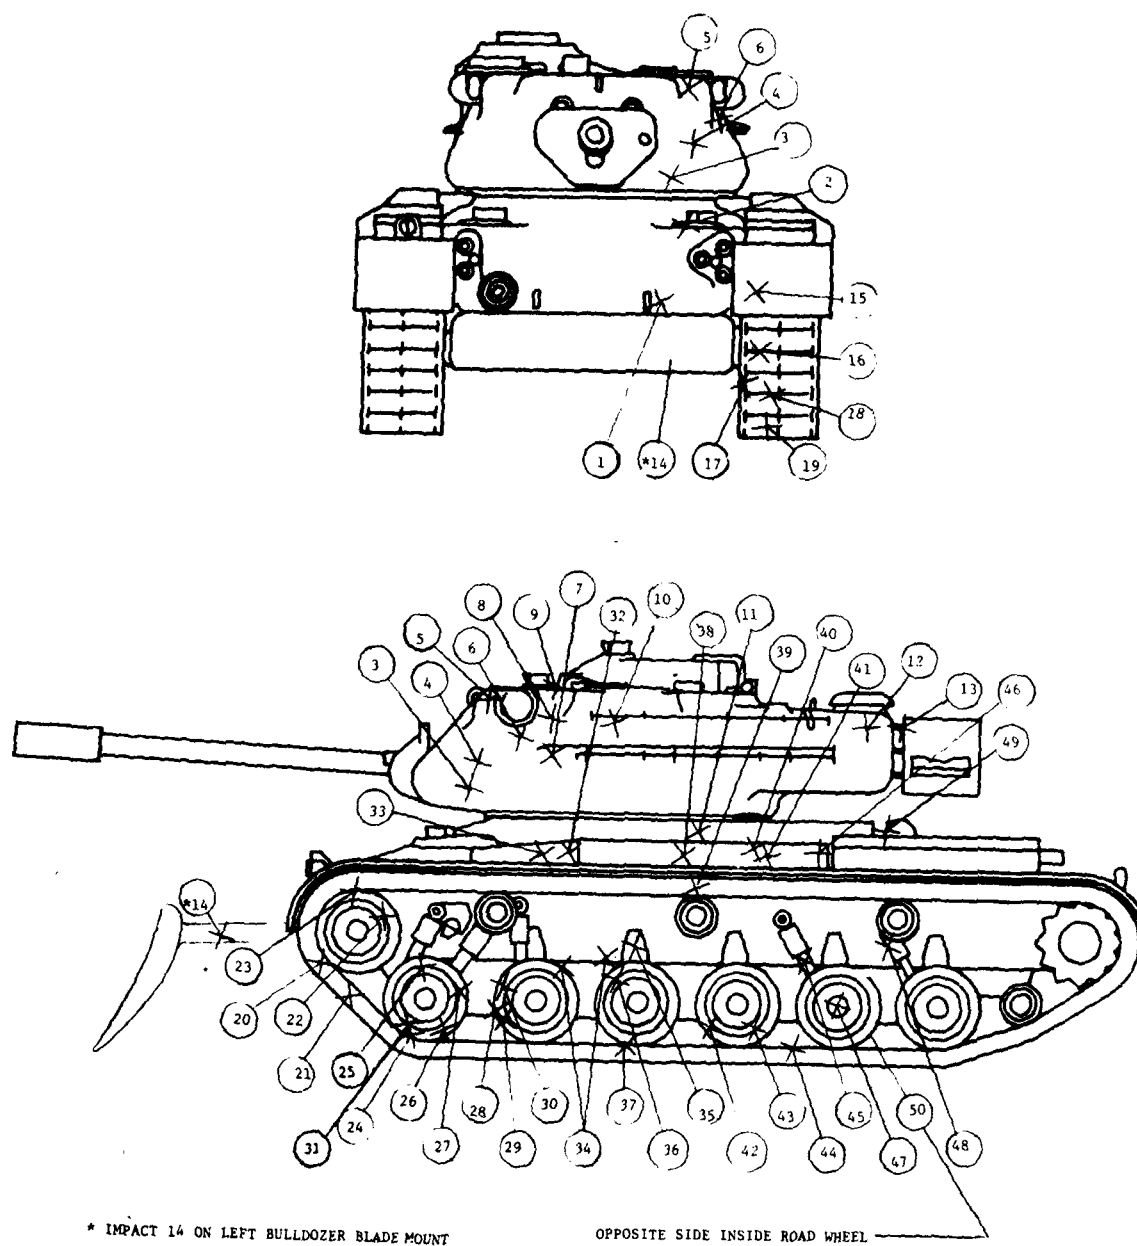
FIGURE 77. Impact Diagram, Target 36.

100% M-Kill, resulting from the following projectile impacts, shown in Figure 77:

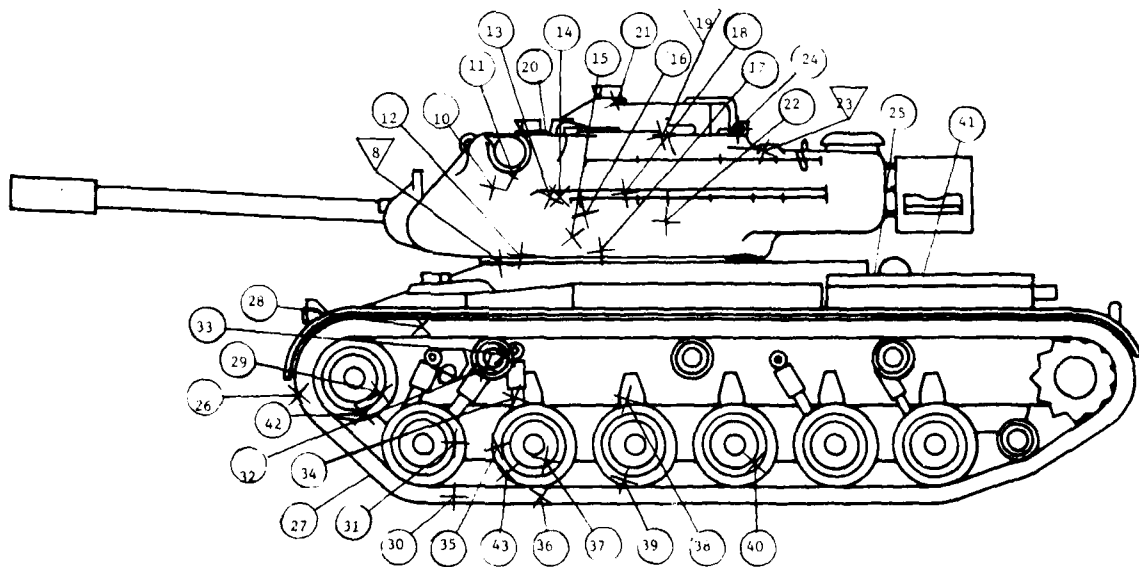
FIGURE 81. Impact Diagram, Target 37.

80% M-Kill and 100% F-Kill resulting from the following projectile impacts, shown in Figure 81:

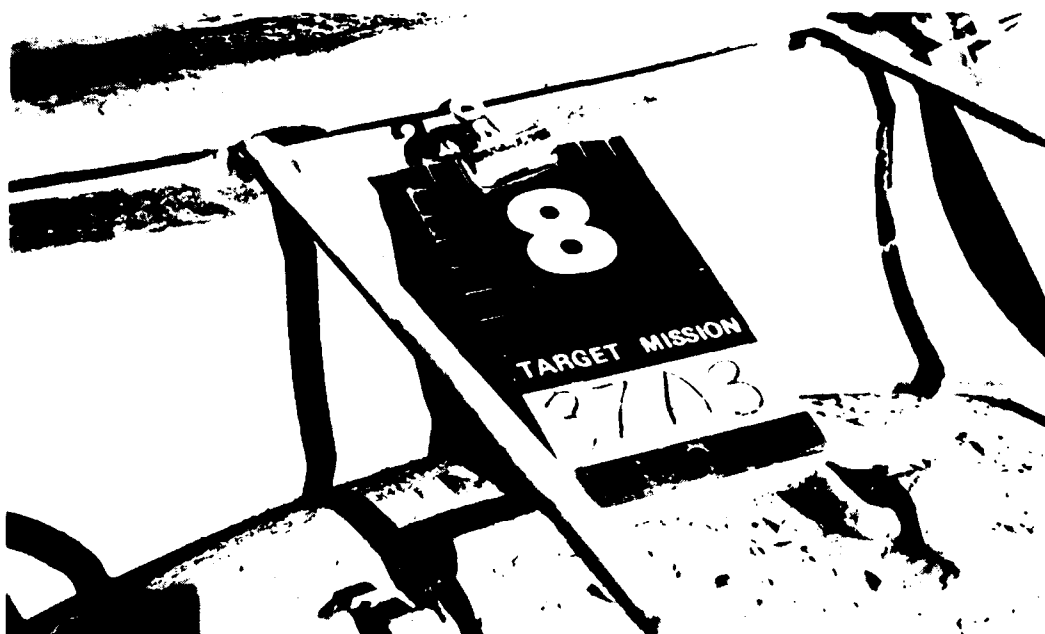
- b. F-Kill: A 100% F-Kill was assessed because of Impact 8, (Figure 82), which perforated the turret ring and jammed the turret; Impact 9 (Figure 83), which perforated the turret ring, jammed the turret, ignited propellant in an ammunition round in the ready rack, and wounded two crewmen (gunner and loader - Figures 84 and 85) and Impact 19, which perforated the lip of the loaders hatch, contributing to the loader casualty. One other perforation (Impact 23) of the antenna base aperture made no contribution to the kill. Two additional hits (Impacts 5 and 12) in the turret ring may have contributed to the jammed turret.

FIGURE 82. Impact Eight, Target 37, Perforations of Turret Ring which Jammed Turret.

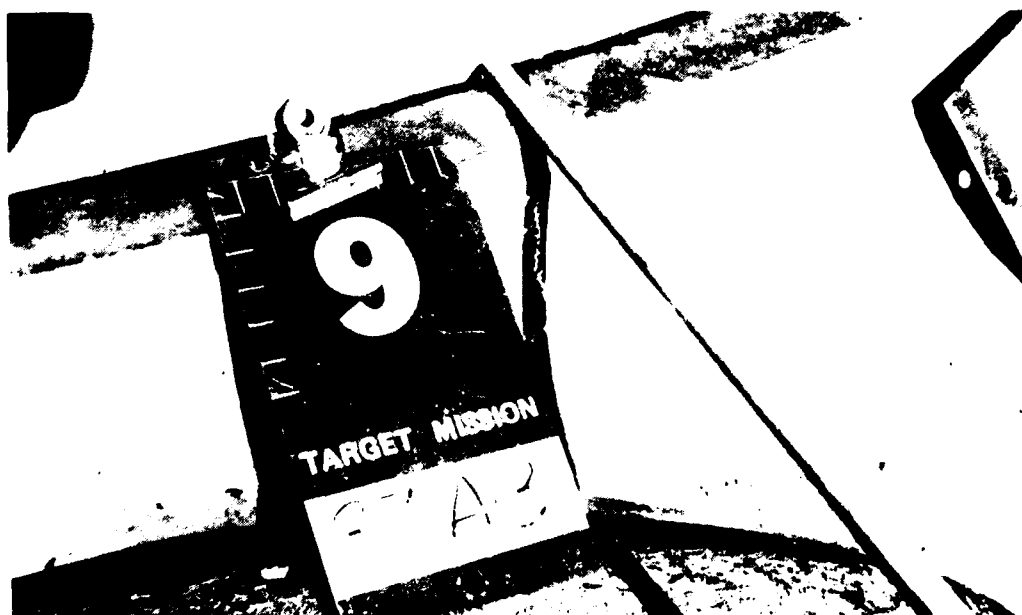
FIGURE 83. Impact Nine, Target 37, Perforations of Turret Ring which Jammed Turret.

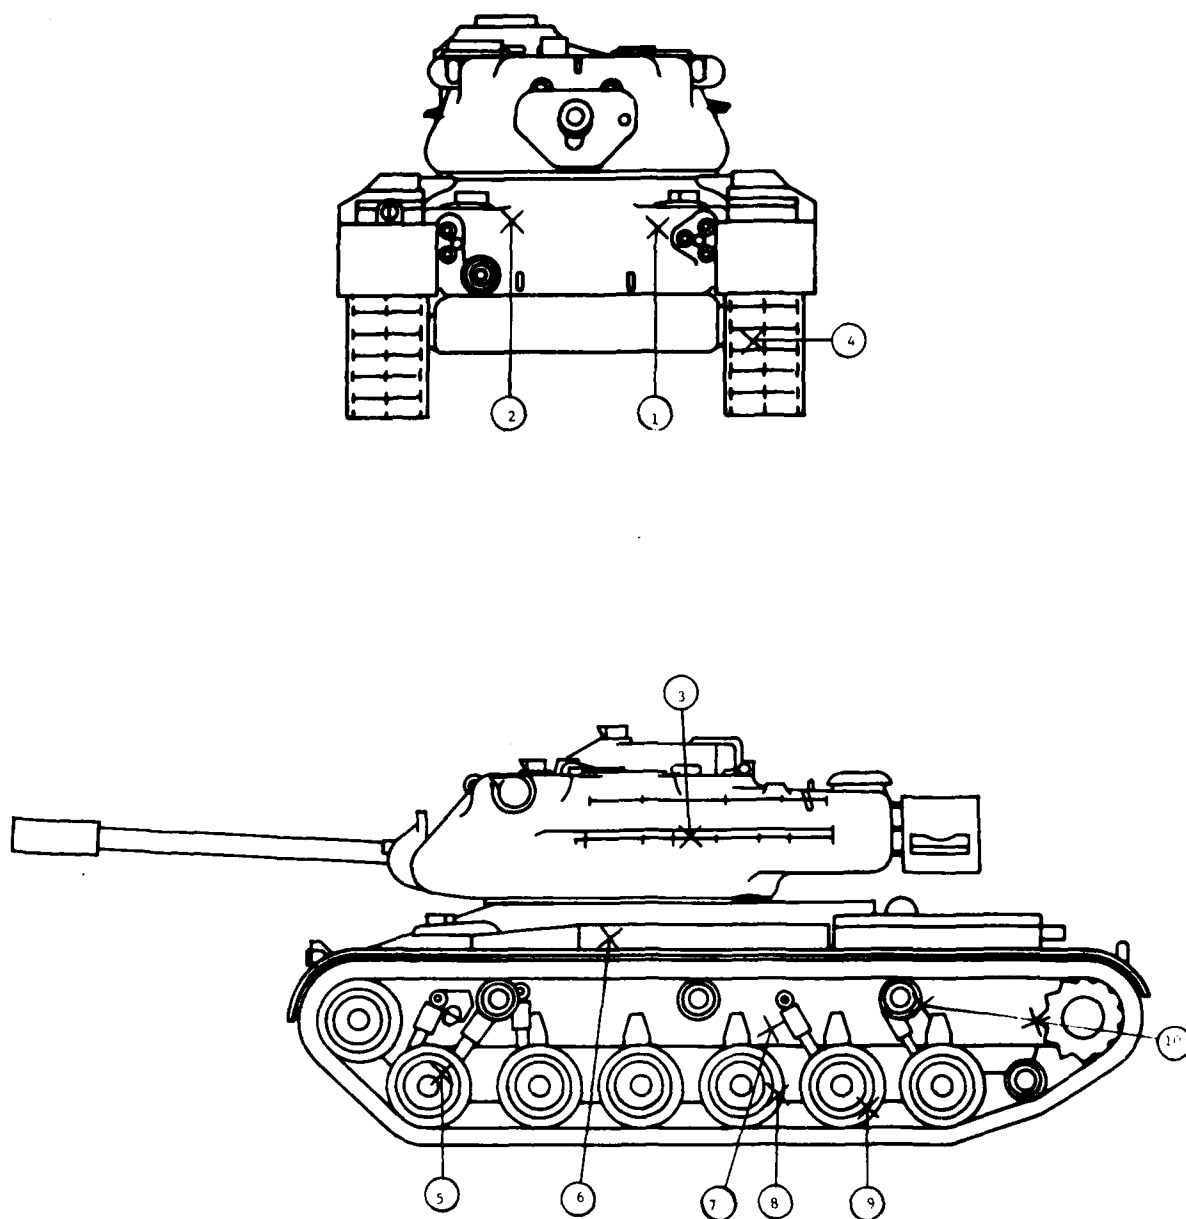
FIGURE 86. Impact Diagram, Target 38.

100% interdiction M-Kill, resulting from the following projectile impacts, shown in Figure 86:

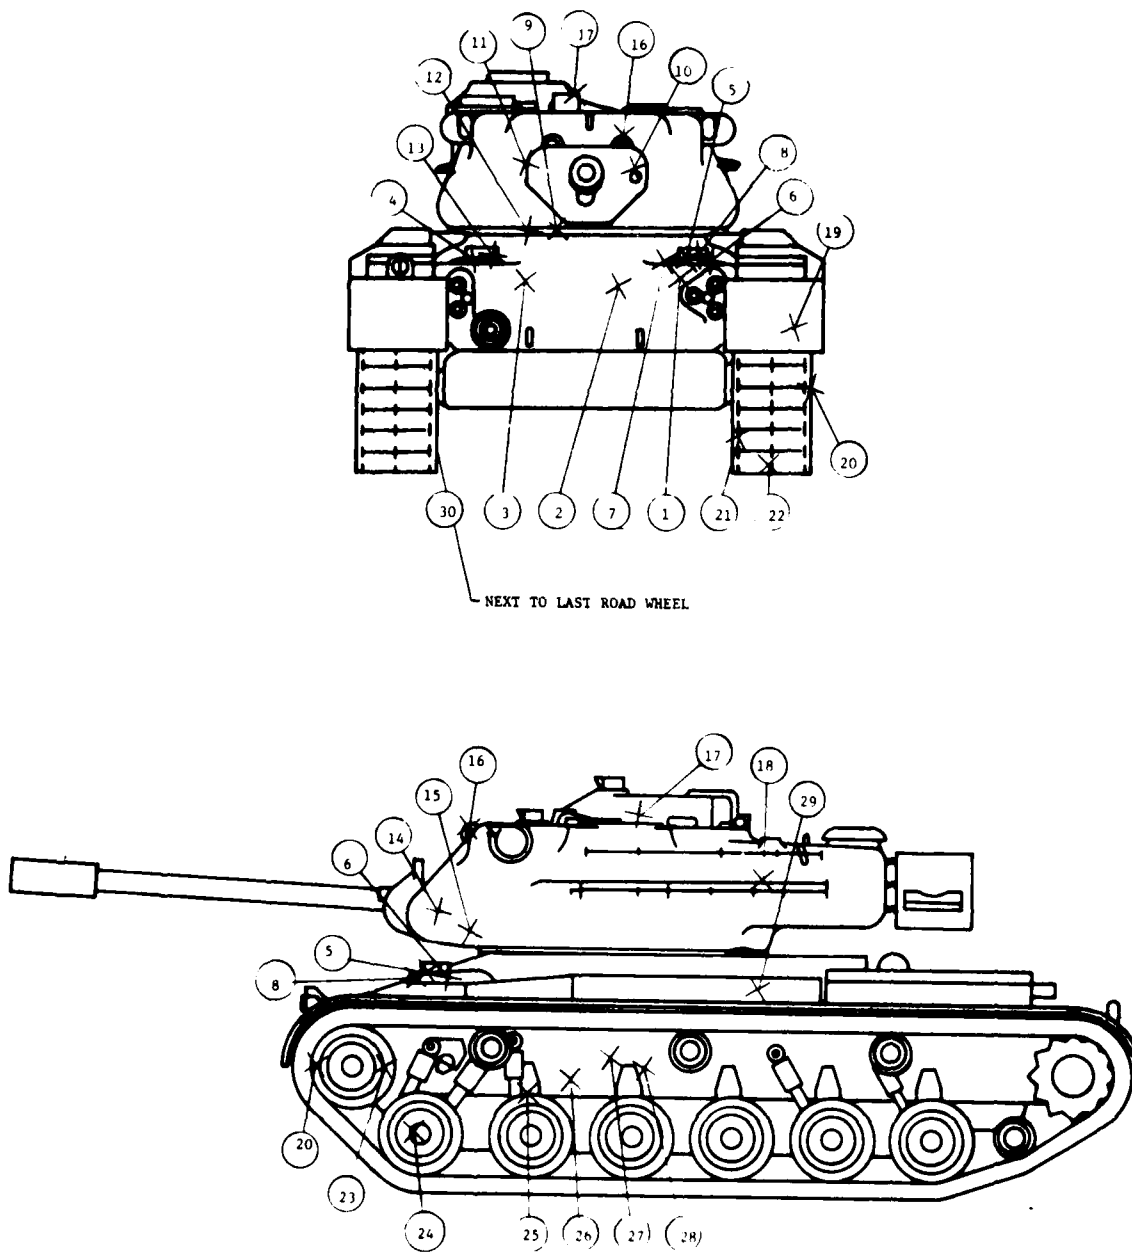
FIGURE 89. Impact Diagram, Target 39.

100% interdiction M-Kill and 50% F-Kill, resulting from the following projectile impacts, shown in Figure 89:

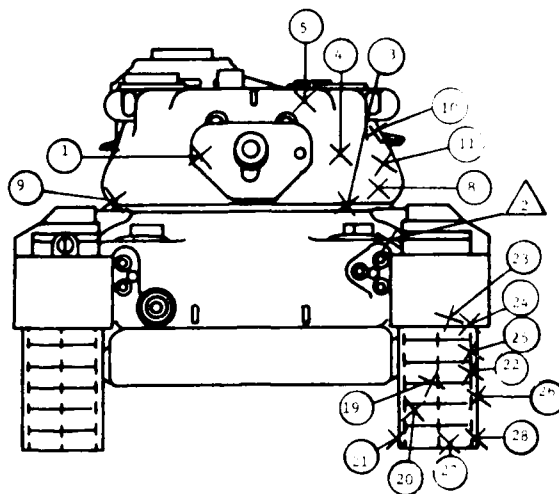
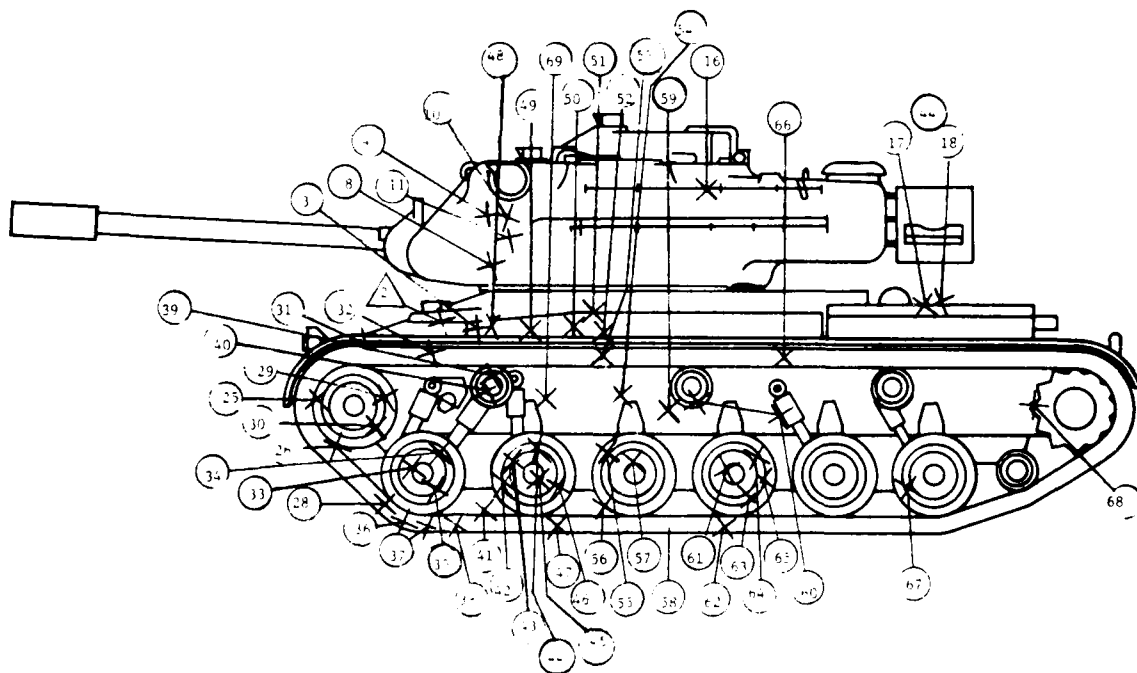
FIGURE 92. Impact Diagram, Front and Side, Target 40.

100% M-Kill, and 100% F-Kill, resulting from the following projectile impacts, shown in Figures 92 and 93:

NOTE: Impacts 69, 70 and 71 not shown.

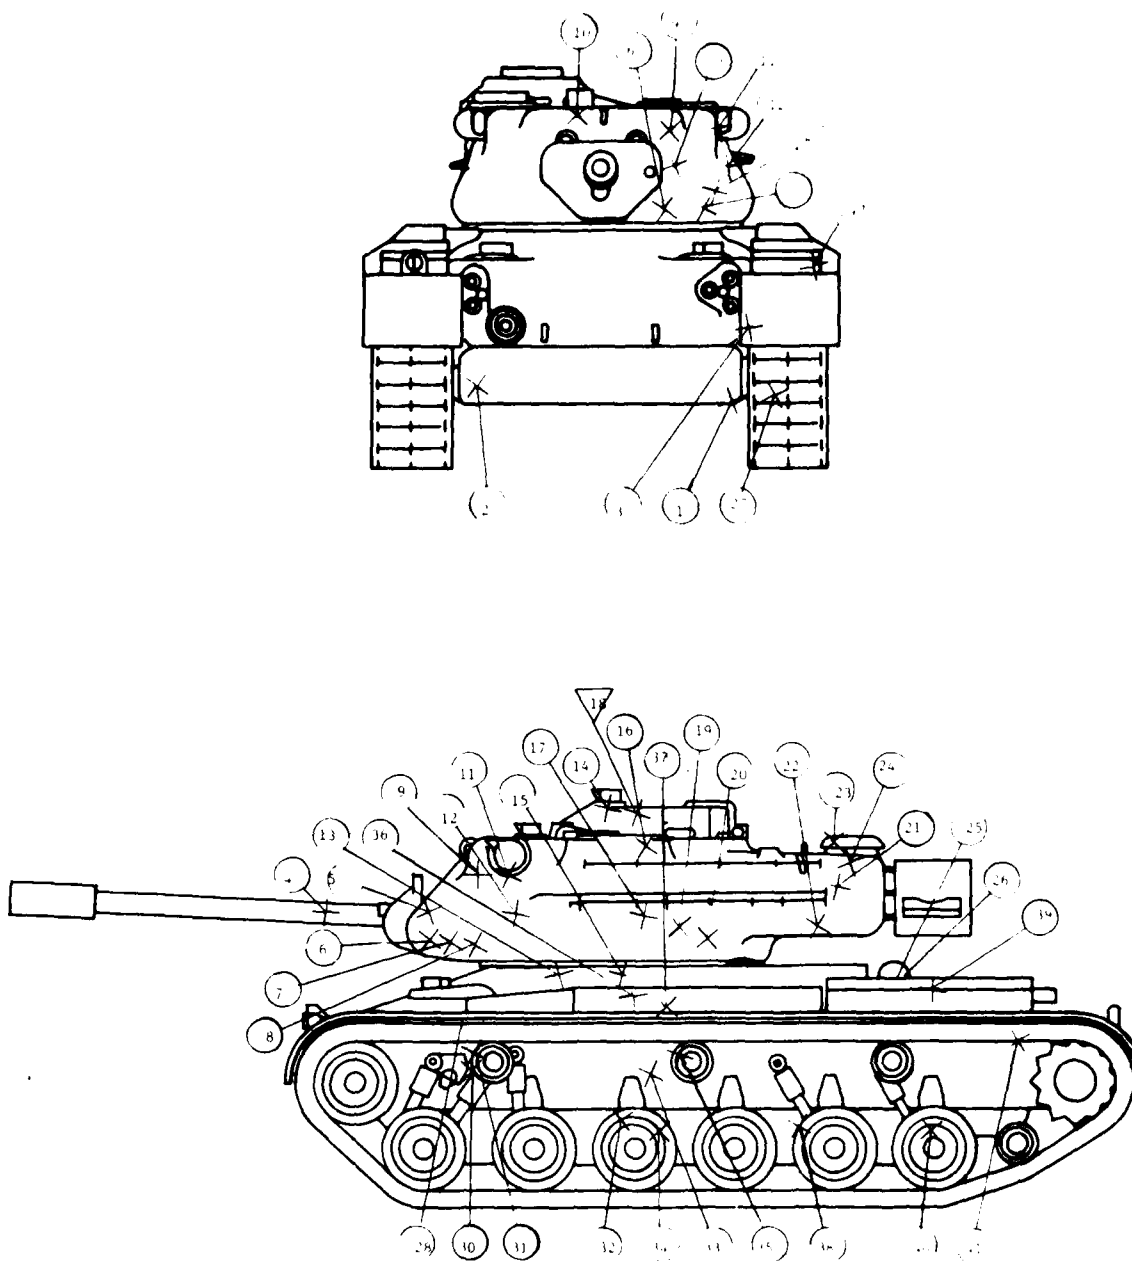
- a. M-Kill: Mobility was estimated to have been degraded by 65% due to crew casualties caused by Impact 18. Minor damage to the track and suspension system, caused by Impacts 27, 30, and 32, also made a contribution to the kill.
- b. F-Kill: A 95% F-Kill was assessed for Impact 18, shown in Figure 107, which perforated the commander's cupola into the fighting compartment and caused commander and gunner casualties. Impact 11, which destroyed the range finder blister, also made a significant contribution to the kill.

FIGURE 106. Impact Diagram, Target 41.

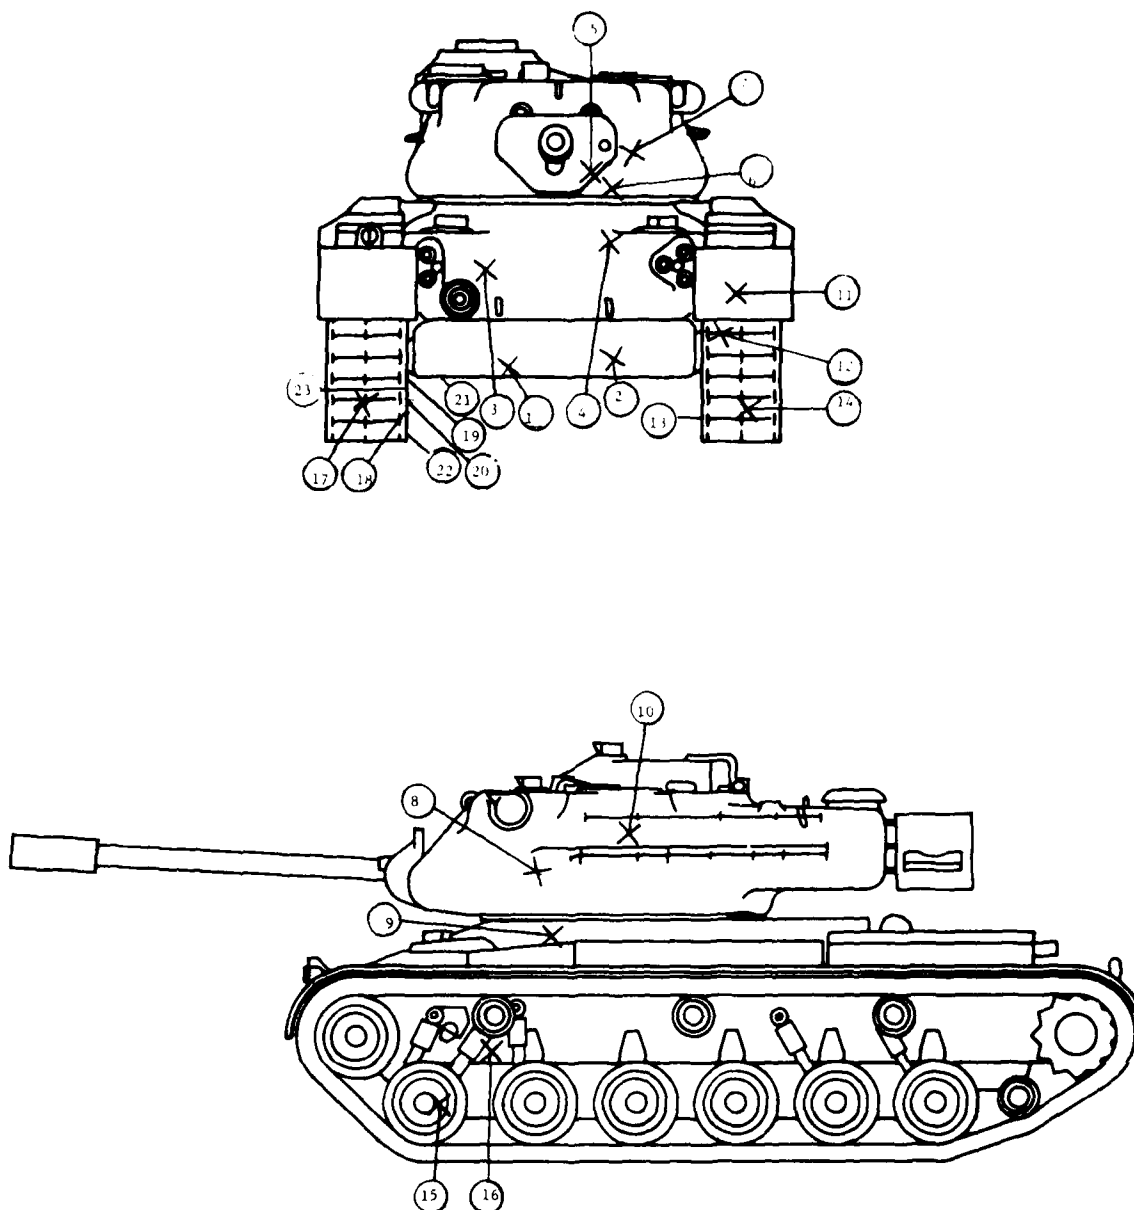
A 100% interdiction type M-Kill, after an estimated 2000 meters travel, was assessed for Impacts 17 and 18, shown in Figures 109 and 110, respectively, which destroyed two (2) end connectors on opposite ends of the same track pins, leaving only the track center guide to hold the track together. Cumulative damage to the track and suspension system by 5 other impacts contributed to the kill.

FIGURE 108. Impact Diagram, Target 42.

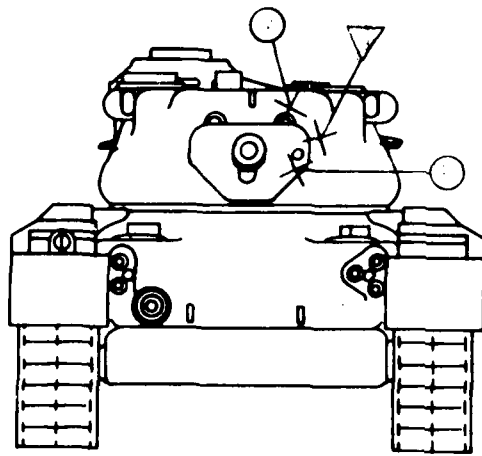
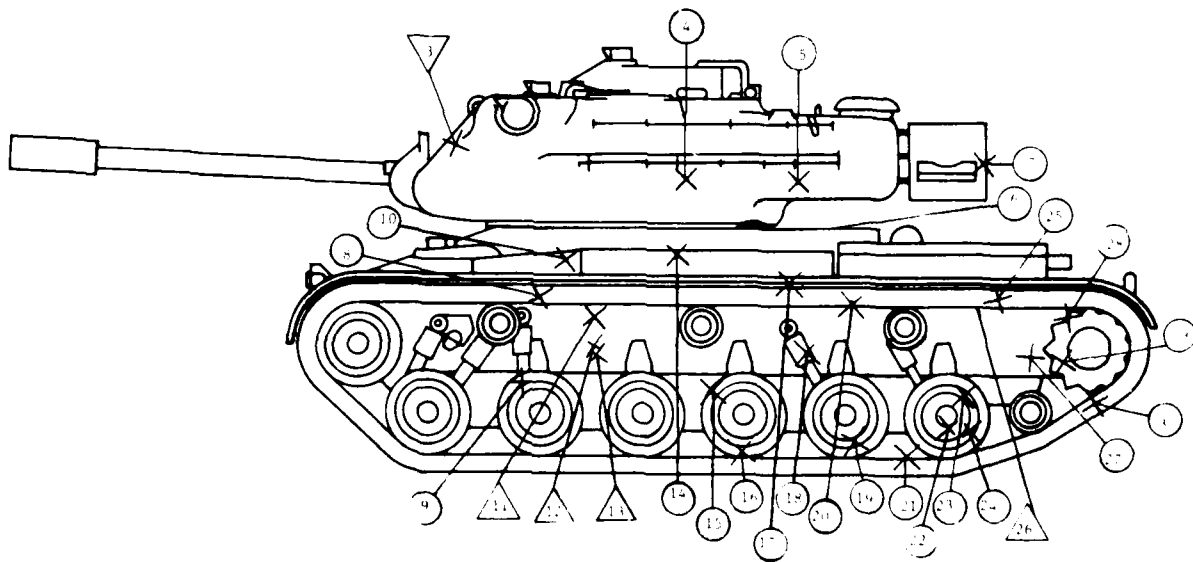
- a. M-Kill: Impacts 25 and 28 penetrated the left final drive, shown in Figures 112 and 113, respectively. Impact 22 destroyed the left #6 roadwheel hub (Figure 114). Cumulative damage to the track and suspension system, resulting from 10 other impacts, contributed to the kill.
- b. F-Kill: Impact 3 (Figure 115) perforated the left front turret, severed the recoil cylinder/replenisher flexible hose, and wounded the tank commander and gunner (Figures 116 and 117). Four (4) other perforations of the hull had little or no behind-the-plate effects.

FIGURE 111. Impact Diagram, Target 43.

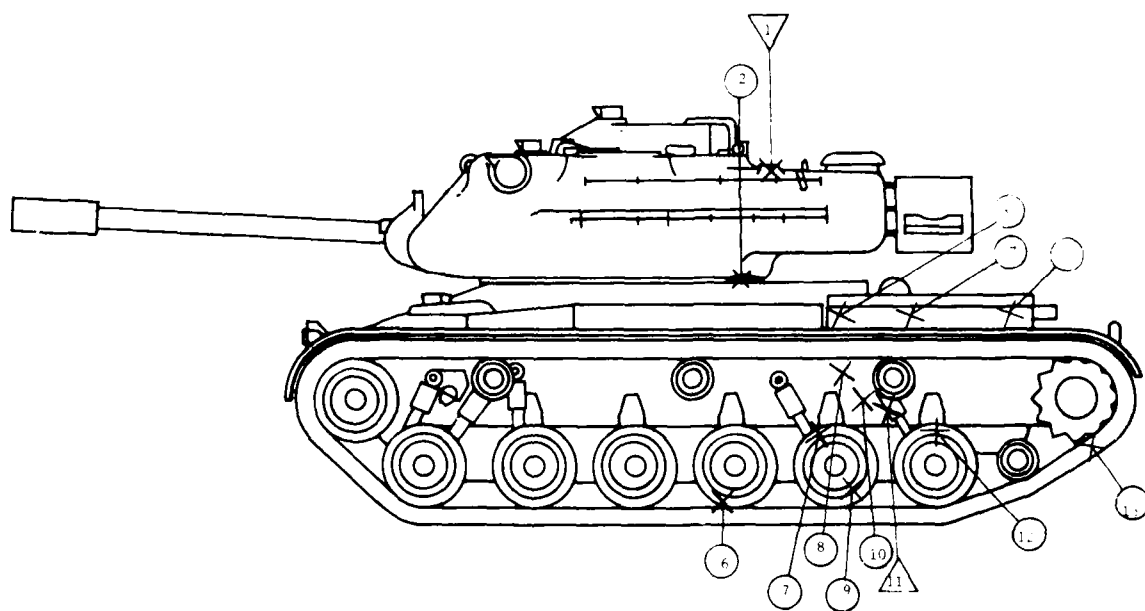
- a. M-Kill: Impact 11 (Figure 119) perforated the left hull and penetrated the oil cooler area; if the oil cooler had been in place, it would have been damaged or destroyed. Impact 12 ruptured the left final drive causing an oil leak. One other impact on the track destroyed one track center guide, making a minor contribution to the kill.
- b. F-Kill: Impact 1 (Figure 120) perforated the left top of the turret and caused casualties to two (2) crewmen (tank commander and gunner). No mechanical damage that would contribute to an F-Kill was observed.

FIGURE 118. Impact Diagram, Target 44.

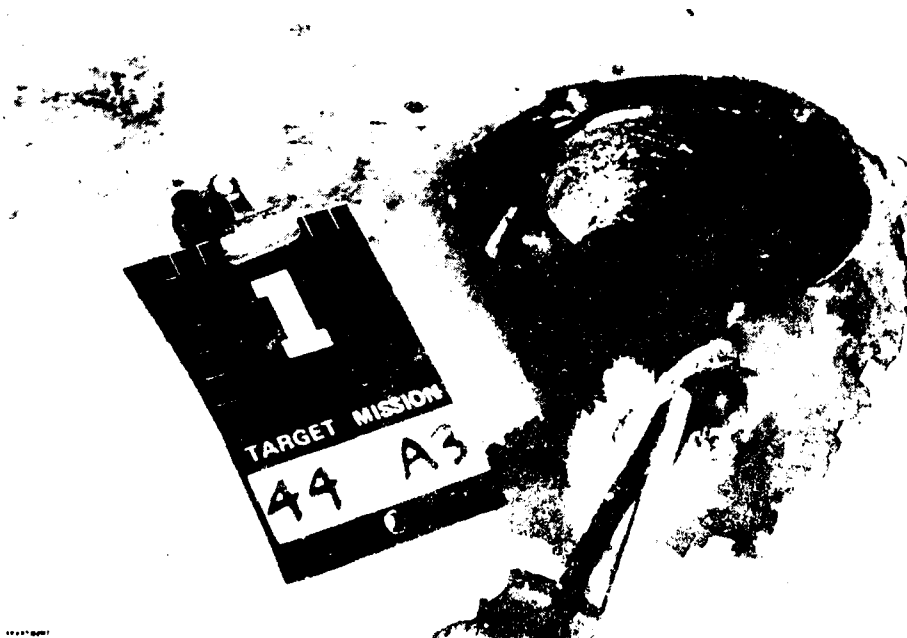
FIGURE 120. Impact Eleven, Target 44, which Perforated the Left Hull Armor into the Engine Compartment and Destroyed the Main Gun.

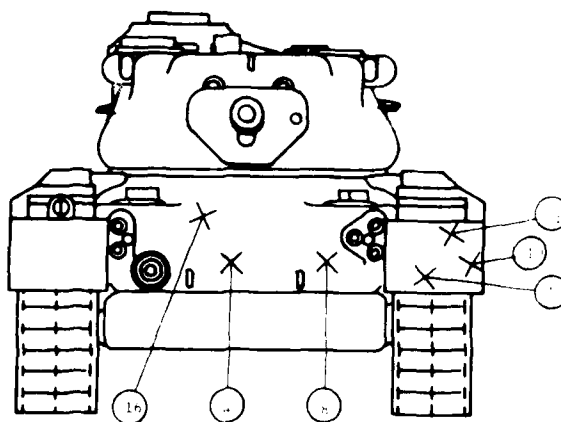
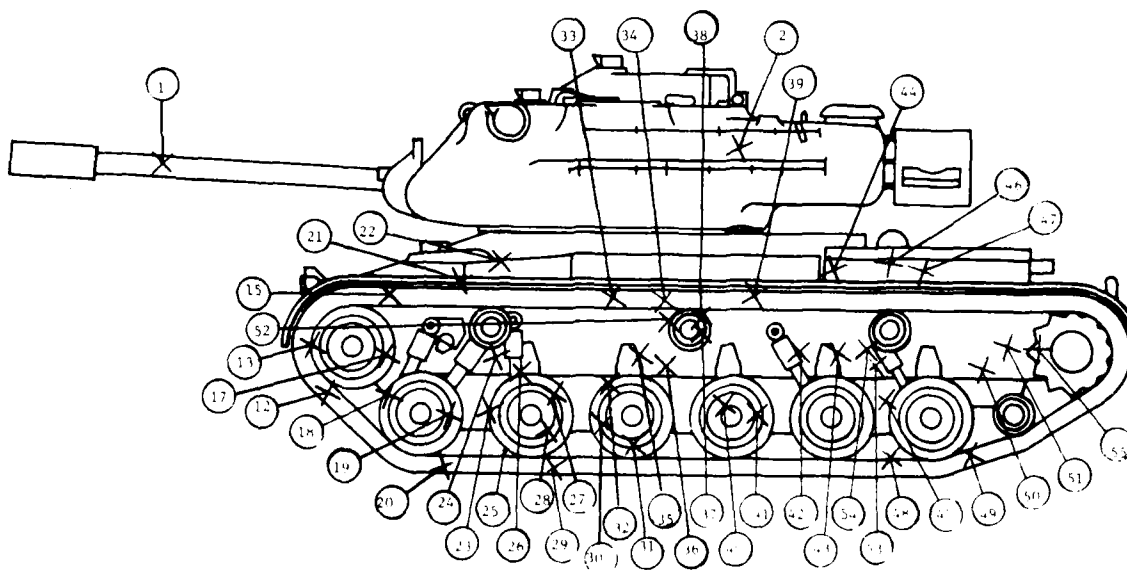
IMPACTS 3, 4, 5, 6, 7, and 14 ON BULLDOZER BLADE BRACKETS

NOTE: Not shown in the impact distribution drawing above, but recorded in firing results are hits number 3, 5, 6, 7 and 14 on bulldozer blade, and its mounting bracketry and actuating hydraulic cylinder.

FIGURE 121. Impact Diagram, Target 45.
